Economic Analysis of Tactile Pavement Markings

SH8 Between Twizel and Omarama

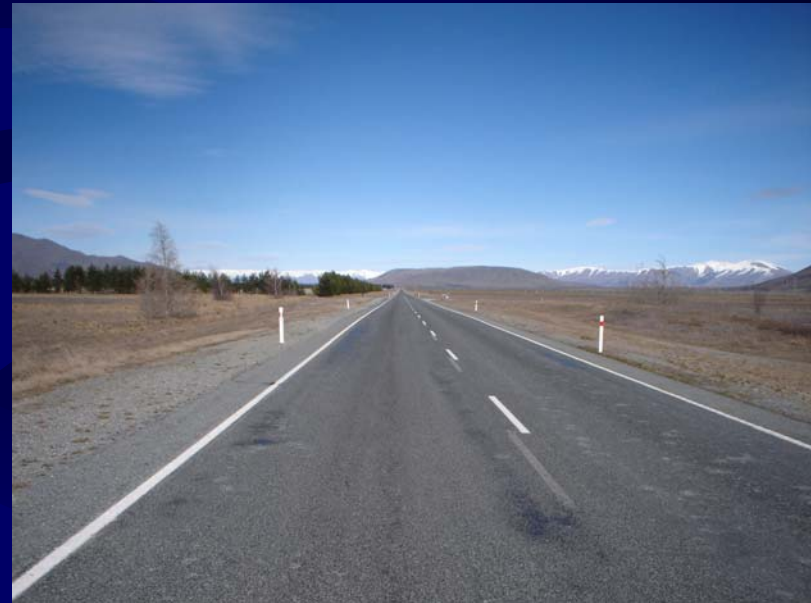
Site Description

- SH8
- Straight and flat
- 8.5m seal width
- Wide road corridor
- Power poles

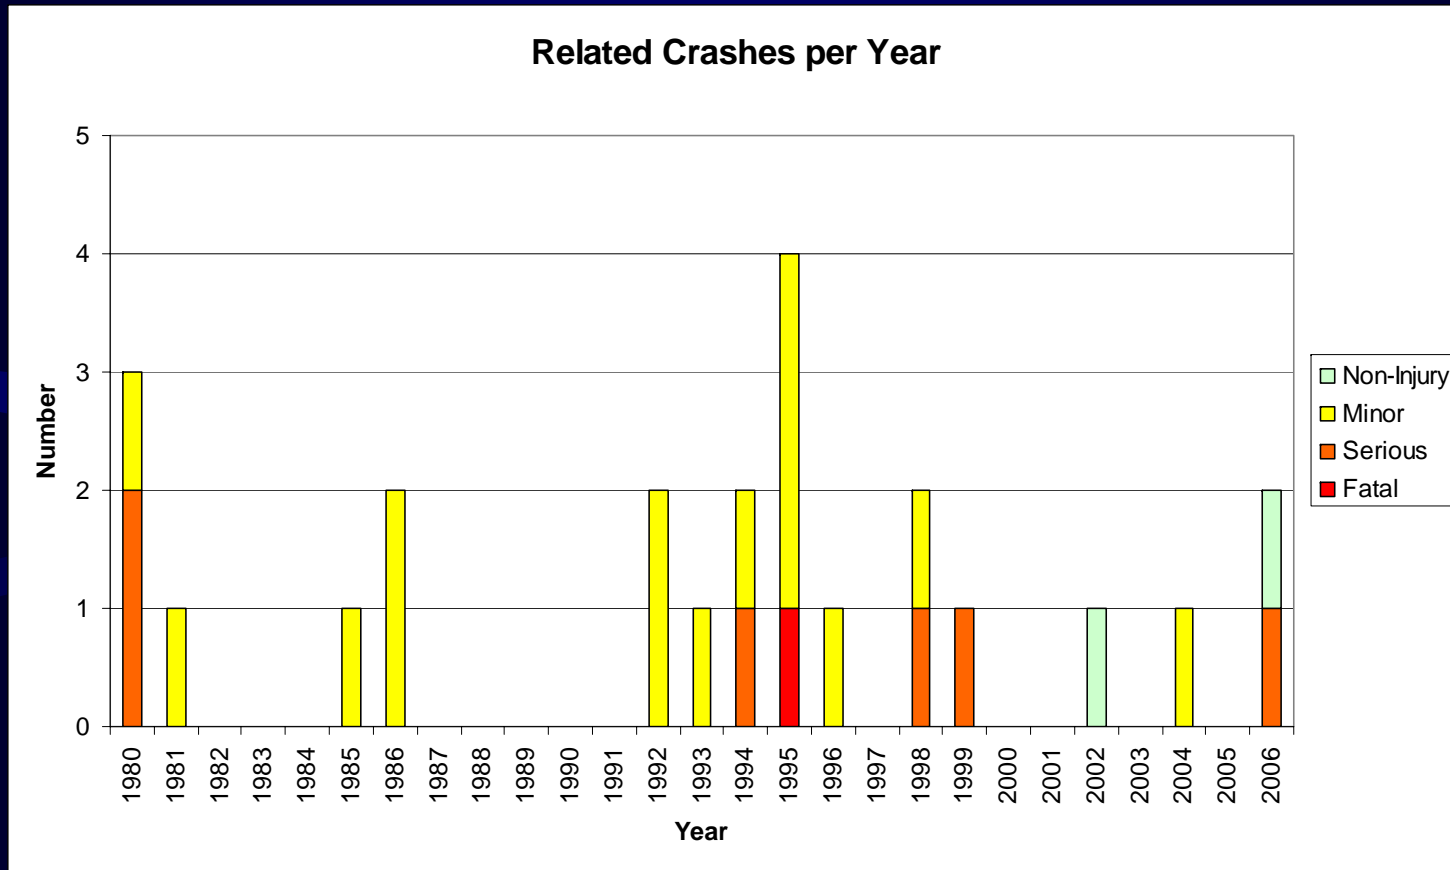
Crash History

- SAR (1994–1998) 1F, 2S, 6M & 1NI
- Before (1996–2000) 2S & 2M
- After (2001–2005) 1M & 1NI
